Tests Of HXR Undulator Covers

Z. Wolf

2/25/21

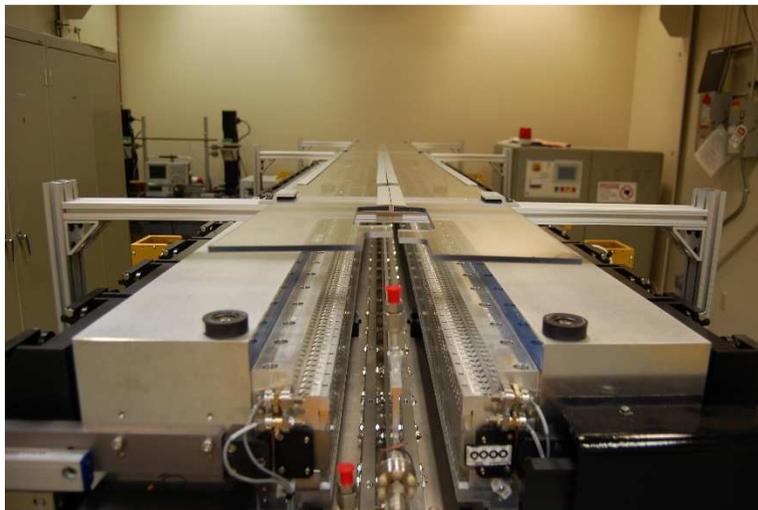
Covers were recently purchased to place on top of the HXR undulators to keep debris from falling into the gap when work was done overhead in the tunnel. A photo of a cover is shown below.

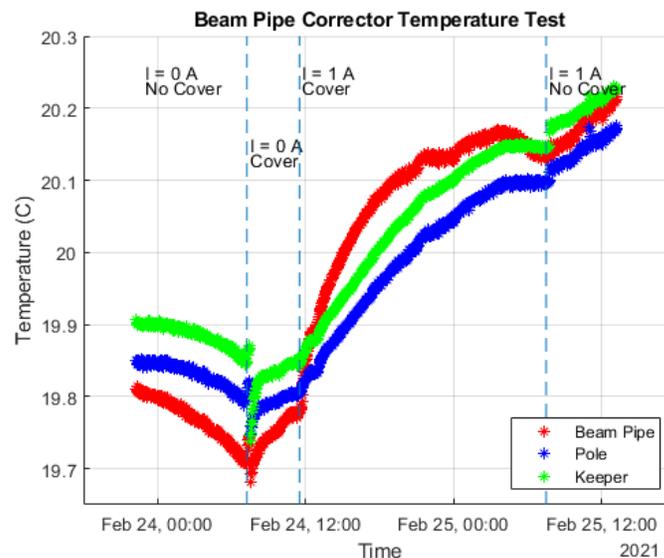
Removing the covers did not make the temperature go down, as might be expected. In fact, the temperature went up slightly because the room temperature was slightly higher than the undulator temperature. It appears that the covers allow adequate ventilation and do not trap heat from the beam pipe.

Note that the beam pipe temperature rose by 0.4 deg C when current was applied. This is near the limit where the magnet temperature is affected at small gap.

This test was performed in the assembly area of the MMF which has modest (± 0.5 deg C) temperature control. One can see in the plot that the temperature is rising during the daytime which make precise measurements difficult. The results are adequate, however, to show that the cover has minimal effect on the undulator temperature. The undulator gap for this test was 120 mm. The controller was disconnected, so no additional measurements at different gaps were performed for this test.
