## Post-Removal Examination of GTF Cathode #2

Robert E. Kirby  
Physical Electronics Group  
SLAC

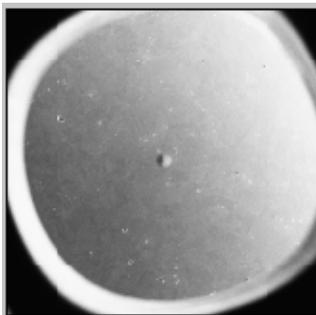
LCLS1.TIF  
1024x1024x8(Gray)

**Photo1** is a white light image of the cathode surface, showing considerable activity in the central one-third of the plate diameter. The low-magnification SEM version of this, **LCLS1**, shows that the activity is actually present over the entire PC surface, but that most large features are near the center third. Also evident is the central machining defect.

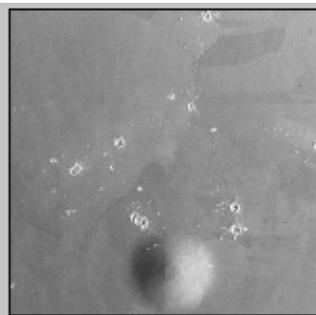
LCLS3.TIF  
1024x1024x8(Gray)

**LCLS3** shows the defect at higher mag (the defect is 400 micron diameter) and activity near it (but, interestingly, no arcs on it). Activity on the PC surface was not uniform but clustered in areas, usually with a few large breakdown features (25 microns) accompanied by many smaller (5 micron) arcs (**LCLS6**). A few arcs occurred on grain boundaries, suggesting that sub-surface gas was involved in the plasma formation. But most arcs occur on grain bodies. The larger arcs are clearly multiple “hits”; presumably, plasma heated the surface, releasing more gas and causing a larger channel to form. These observations are consistent with studies done on other high surface field devices. For example, they are identical to activity seen on NLCTA cell irises.

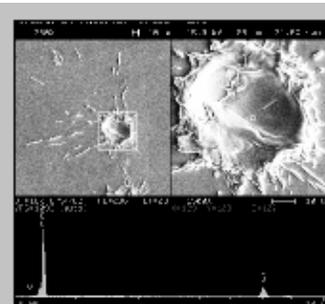
LCLS4.TIF  
512x512x8(Gray)

**LCLS4** is a closeup, with an x-ray spectrum, of a large arc. Only copper was identified in the crater bottoms and rims. However, randomly distributed around the PC surface was a low density of carbon inclusions or, alternatively, carbon-filled pits (**LCLS5**). Their source is unknown but they may be the locations of the original etch pits observed last year. They are about the same size (10 microns) and surface density.
