LCLS-TN-99-10
September 1999

A Brief Report on a Brief Examination of the Electropolished GTF Cathode

R. Kirby and G. Mulhollan

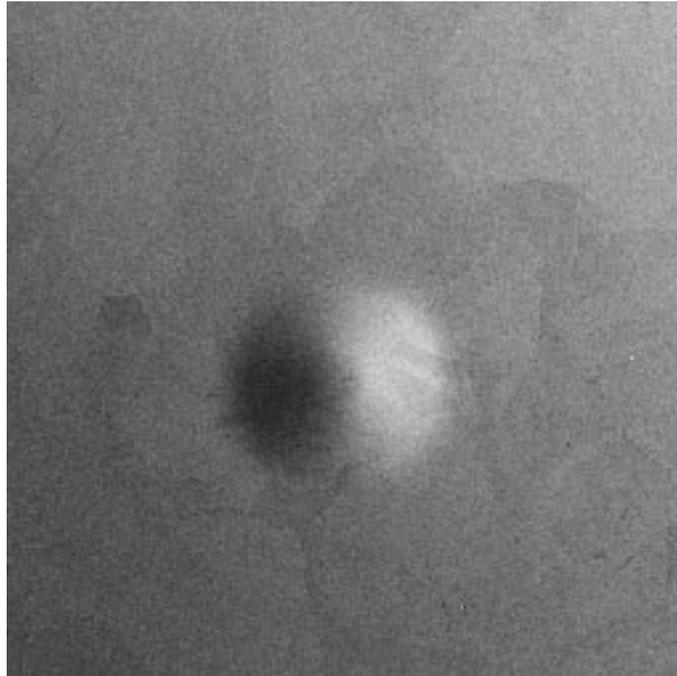
Figure 1. 50x view of center defect. The base diameter is ~400 microns. This feature is well rounded suggesting it was present during the electropolishing. Note the visible grain structure.

center peak, large radius defect and overall surface structure. The center defect, as seen above in fig. 1, is roughly conical in shape with smooth features and is composed of copper. Its size is sufficiently large that it is unlikely to act as an emitting site. This is due to both the roundness of the tip and the relatively small height to width ratio. Together these imply the field enhancement factor, β , is less than four².

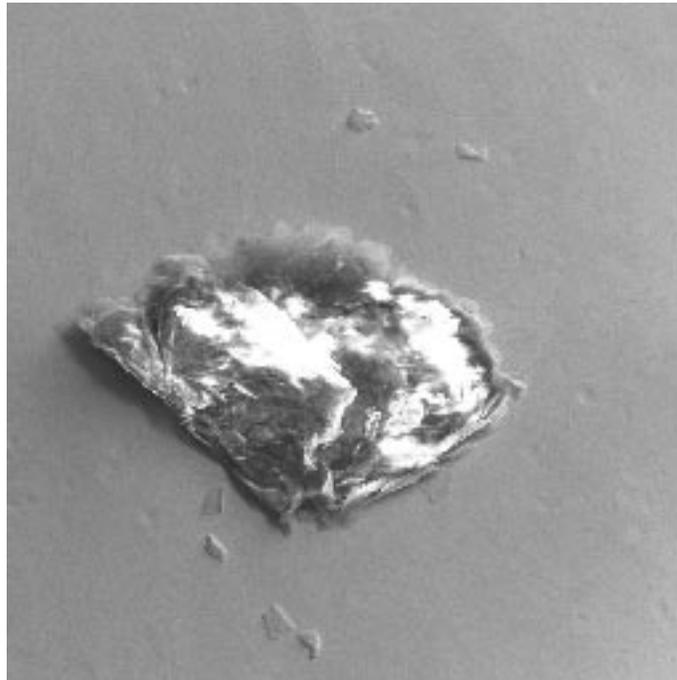
The defect at large radii, though similar in size is morphologically undesirable as it possesses many sharp edges and protrusions. This particle, as seen in fig. 2, is

Figure 2. Particle located at large radius. Note the fine structure and many sharp edges.

composed primarily of carbon and should be removed before insertion of the cathode plate. The overall size of the particle is ~200 microns on an edge.

With the exception of the large particle located far off-center, the cathode plate compares remarkably well with the Klystron test noses that received specialized handling. The lack of oxidation suggests good storage techniques were used.

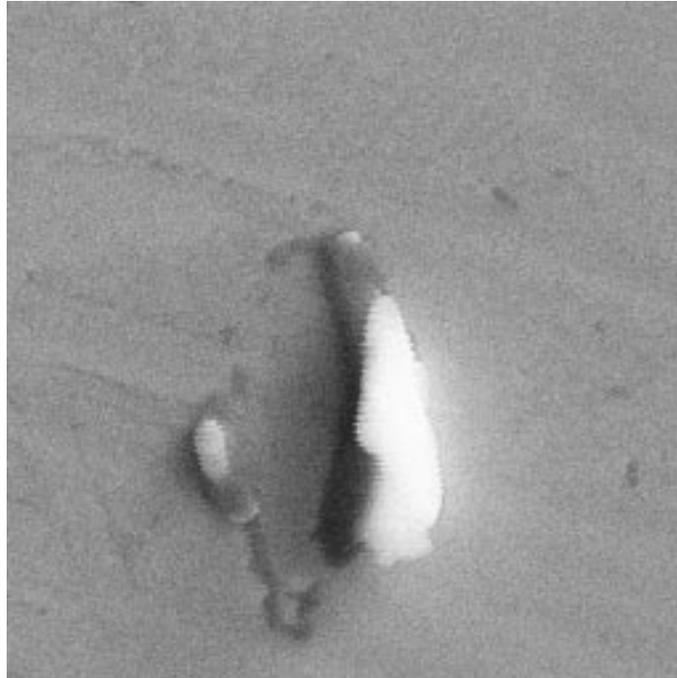
Several very small copper particles with diameters on the order of 1 micron were found during a general survey. As they are quite rounded, it is possible that they were present during the electropolishing phase of the cathode preparation. An example particle is shown below in fig. 3. These particles are primarily copper, but with significant quantities of carbon and oxygen. One particle with a primary composition of calcium, indicative of an origin as some form of airborne dust, was also observed. These particles are not likely to be easily removed since they may be partially fused to the surface.

Figure 3. Copper particle found at random location on surface of cathode. Note the roundness of the edges and the 'slime trail' suggesting the particles moved during the brazing process.

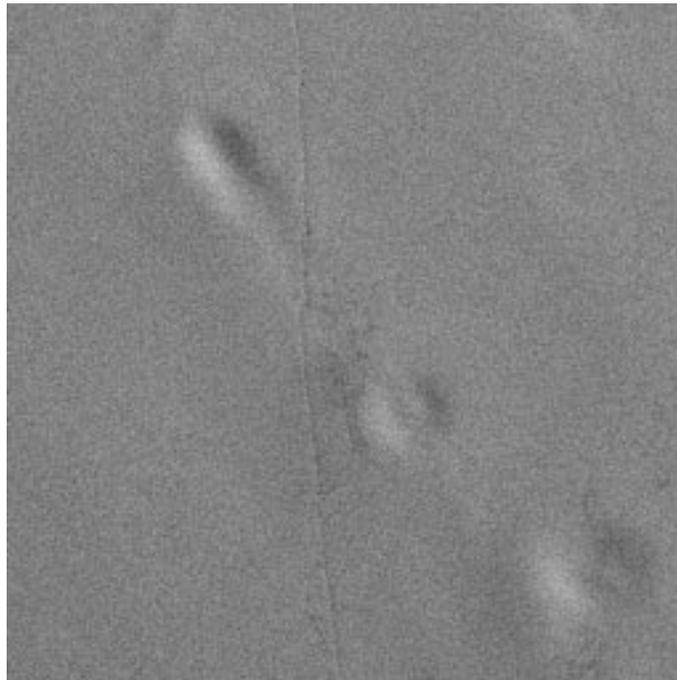
The surface defects are not limited to the presence of adhering particles; voids or pits with sizes on the order of 10 microns were also observed. These pits are very likely the result of the excessive electropolishing the plate received.

Figure 4. Indentations in the surface. The orientation of the shadow (to the right here) is the opposite of that of the cone in fig. 1. Due to this effect, we know that these are indentations and not extrusions.
