LCLS-TN-99-11
October 1999

An Examination of the Laser Cleaned GTF Cathode

J. Francis, R. Kirby and G. Mulhollan

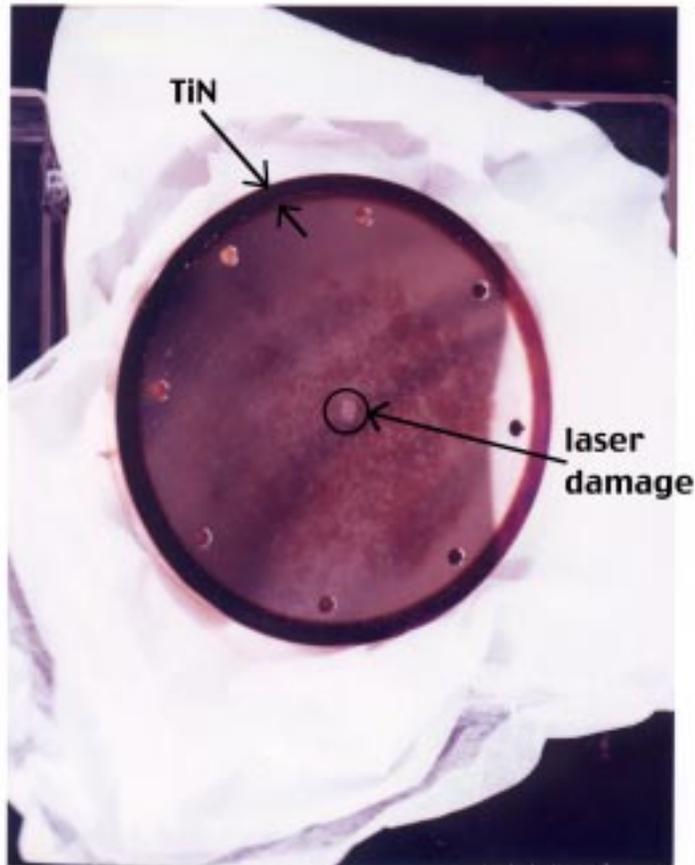
Figure 1. Macroscopic view of cathode plate.

The front of the cathode plate had four clearly discernible types of surface quality.

The first was the dark ring of the TiN coating, the second was the union of all light colored areas which covered ~ 45% of the surface, the third the union of all darker colored areas which also covered ~ 45% of the plate and the last region was a small area in the center of the cathode where the laser cleaning had

occurred.

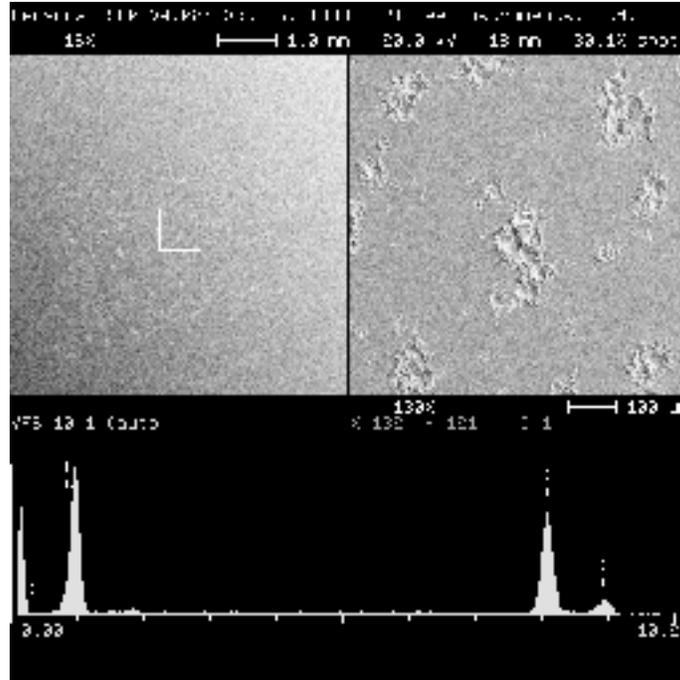
Figure 2. 130x view of center area. The chemical composition of this area was exclusively copper. From this sample, we can estimate the damage to cover about 20-25% of the cleaned area.

Overall, the cathode surface appeared to be of good quality with grain boundaries visible though there was some evidence of occasional grain pullout. As seen in fig. 2, there was no sign of any gross chemical contamination with the x-ray spectrum showing only copper. Damage to the surface was mostly confined to the center region although a few areas away from center were also spotted. The dark regions were likely due to light oxidation.

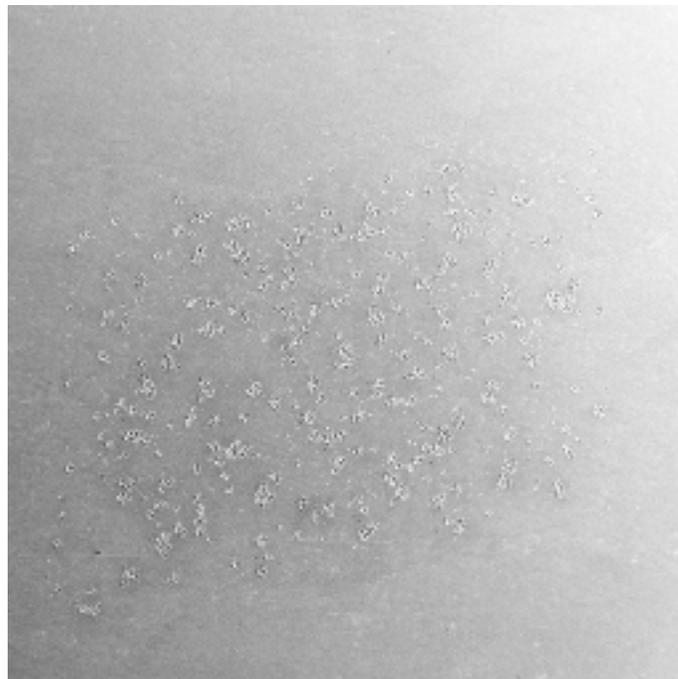
Figure 3. View of laser cleaned area. Size is ~1 mm.

The arrangement of damage from the laser cleaning is shown in fig. 3. There was no obvious pattern even though the laser was rastered over this region. This suggests either inexact rastering or the presence of an occasional hot spot in the laser beam.

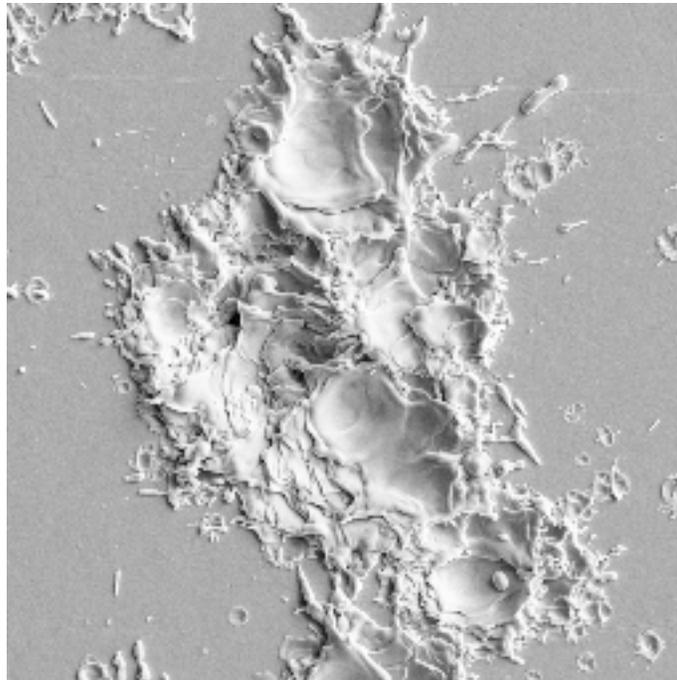
Figure 4. Closeup of a crater caused by laser cleaning.

A closeup view of one of the laser cleaning induced craters appears above in fig. 4. It is clear that this region had experienced several pulses with at least 5 independent craters visible. There was a lot of material splatter as a result of the explosive nature of the creation of the craters. The roughened surface of the crater together with the splatter led to an effective enhancement of the surface area which may account for some fraction of the increased quantum yield.

With the exception of some of the defects located far off-center and the laser cleaned area, the cathode plate showed good quality. The plate could be reused if the surface were remachined to remove the damage.

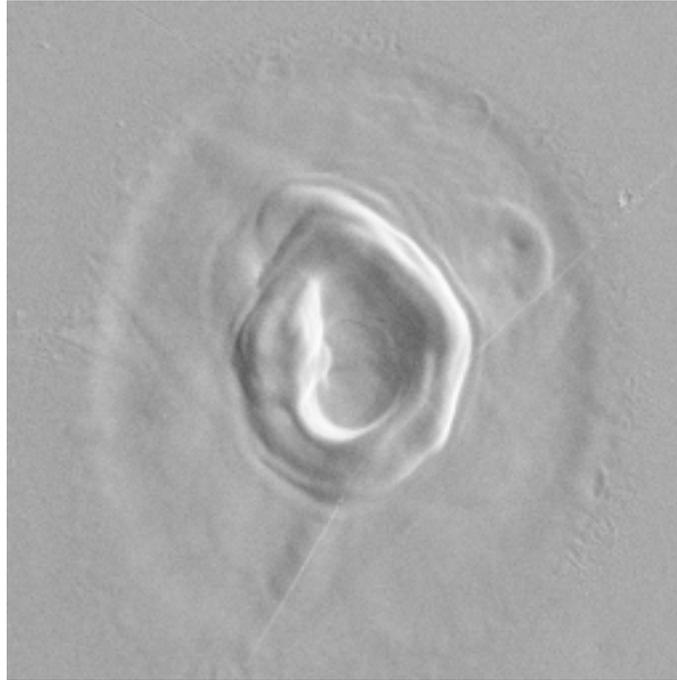
One interesting feature was discovered well away from the region of laser cleaning. This feature was also a crater, but a particularly well smoothed one

which suggested that a lower intensity or longer duration beam may have been the cause.

Figure 5. Closeup view of a crater caused by laser cleaning with a pulse duration long enough to permit local melting and smoothing.
