**SSRL ED&M
DOWNTIME REPORT
2005**

1. Summary

During the 2005 SPEAR SHUTDOWN (August 2 to November 28, 2005) the ED&M Group accomplished a large number of routine downtime maintenance tasks, as well as a significant number of new project and upgrade activities. Some of the more significant activities during the shutdown are highlighted in this Downtime Report.

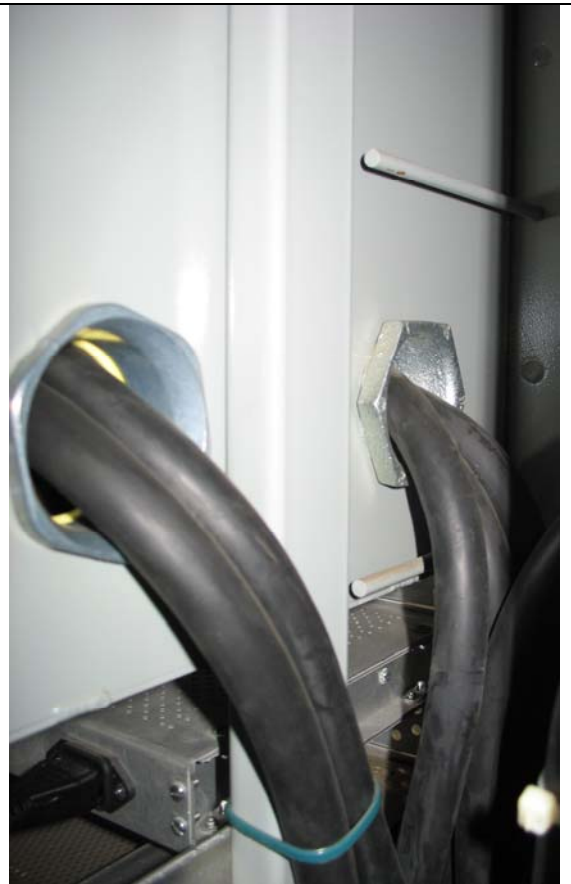
Picture 2.3b New cable penetration on AC distribution box.

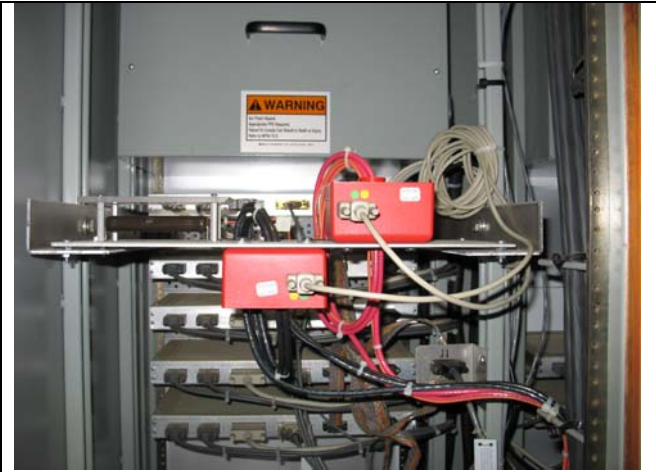
A new TSP power supply was installed. This will allow each TSP switching chassis to be fed from its own power supply. This will help to reduce the time required to flash the TSPs. The installation was done by Critt Taylor and included a new BitBus controller.

Picture 2.4 New TSP power supply installation.

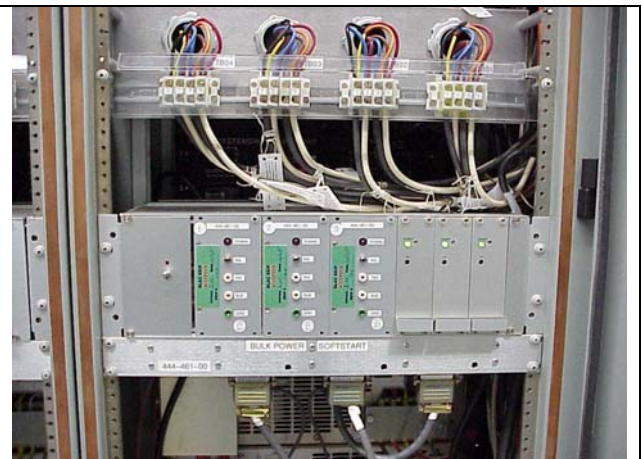
Picture 2.6b MCOR Assembly installed in existing chassis.

An alternative active component based over voltage protection circuit making use of sensor actuated solid state heat sink was designed by Fernando Rafael and Greg Johnson that would protect the power supplies and could be located in the existing chassis space in the back of the racks. A total of 28 over voltage protection circuits were installed to protect the MCOR bulk Power Supplies. See Pictures 2.5a and 2.5b.

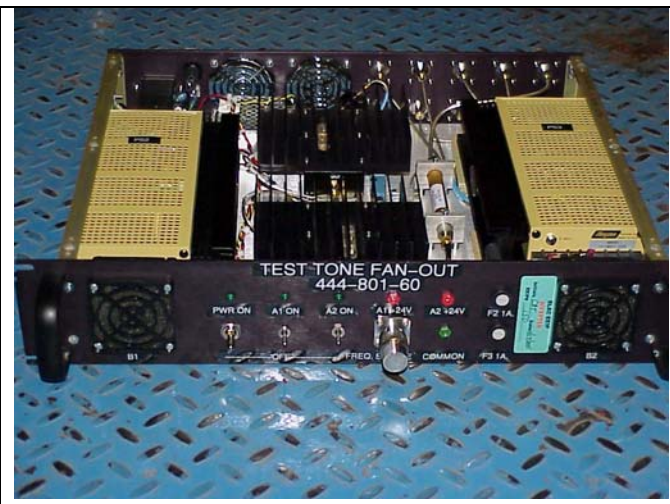
Picture 4.1b New Test Tone Chassis, front view

Picture 4.1c New Test Tone Chassis, top view

Picture 4.1d New Test Tone Chassis, back view

A new high power Test Tone chassis, incorporating required temperature controls, was designed by John Wachter. This chassis provides a Feedback Test Signal to calibrate SPEAR Orbit Electronics. The Original chassis constructed for SPEAR made use of a low power feedback signal. Since then, a coupler with high directivity was added to the path requiring a high power Test Tone Driver to read back the signal. The new chassis met the design specification for RF output power and chassis cooling. Tests were conducted with manual data evaluation and computer data acquisition.

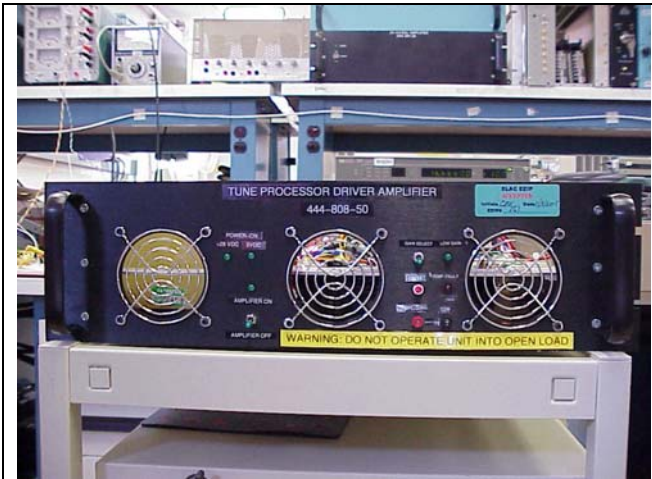
Picture 4.2a New Tune Driver Chassis, front view

Picture 4.1d New Tune Driver Chassis, top view

Picture 4.2c New Tune Driver Chassis, back view

The Tune Kicker modulates the SPEAR pre-injection beam with a very low Frequency and Amplitude signal ~ 10KHz to 500 MHz to fine tune the low density beam at injection. The Original Tune Driver was loaned from ALS and ALS needed their unit returned. A Tune Driver Amplifier was needed for both normal operation and machine physics. After much research for a wide band and mid power amplifier, an EMPOWER amplifier was selected. A chassis was designed by John Wachter with appropriate cooling and Interlock protection to house the amplifier.

The new chassis met the design specification for RF output power and chassis cooling. The chassis interlock function was verified operational at both room temperature and 50 degrees C. Computer data acquisition during an over night burn-in was collected using Labview.

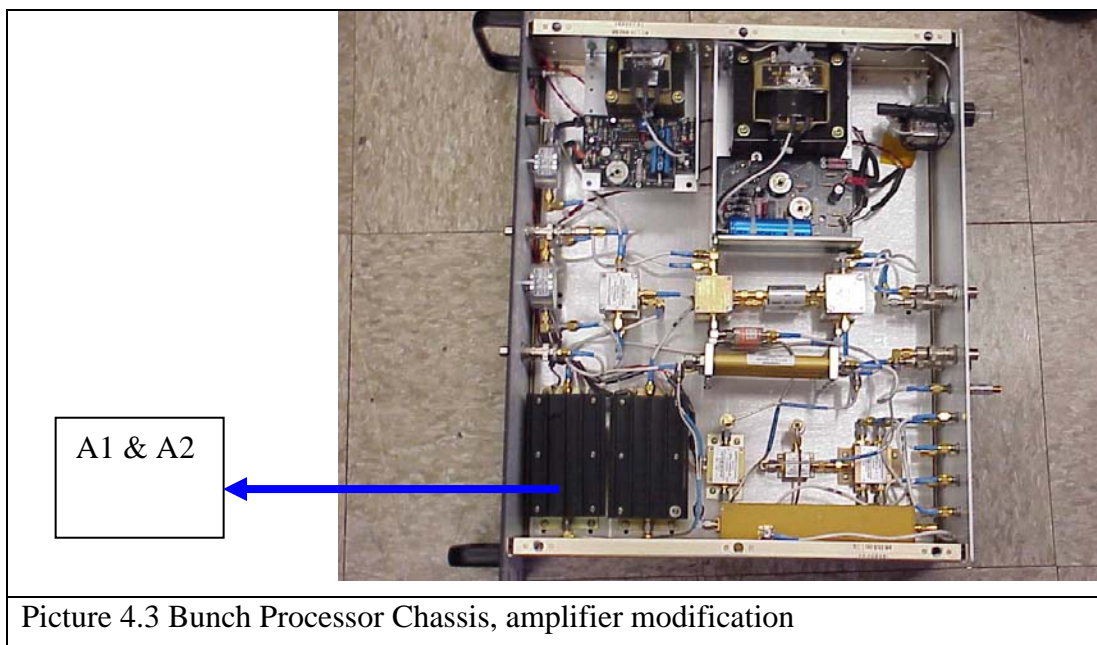
Picture 4.3 Bunch Processor Chassis, amplifier modification

The original Bunch Processor chassis has been in operation for the past two years and had a two high gain power amplifiers installed in the chassis. Since the original installation, it was determined that that the high gain amplifiers were needed elsewhere and low gain amplifiers would be adequate for this processor. A design change was developed by John Wachter. The low gain amplifiers were installed in a spare bunch processor chassis. The chassis attenuators and cables were revised to compensate for amplifier gain change. This is a diagnostic processor thus there was no impact on system operation.

The chassis was bench tested and met the design requirements. Additional operational testing to insure that the down converter and phase shifter are able to capture very low beam density signals began with injection.

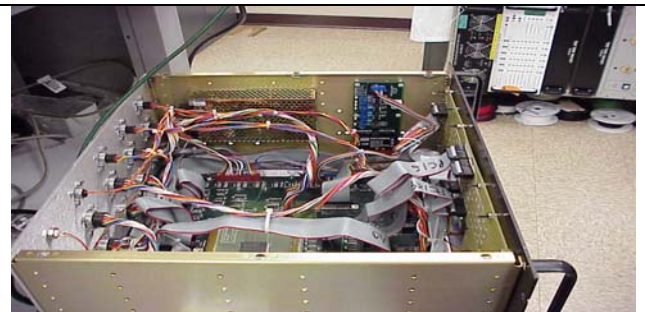
Picture 4.4b New current loop receiver board mounted in the chassis (far side panel)

A new Orbit Interlock Summary Chassis 4-20mA receiver board was designed and built by Reuben Yotam and Scott Walters. This board monitors the loop current and provides independent signals at 18mA and 20mA DCCT currents and when the current loop is broken. It sends the information to the Orbit Interlock Summary Chassis interlock logic. Part of the design included the current monitor fanout board designed by John Wachter. The two chassis were connected and the circuit performed as designed.

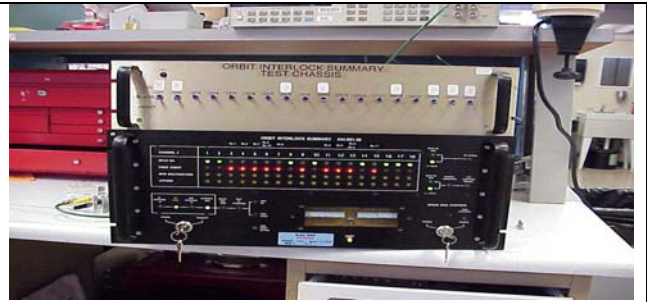
Picture 4.5a Orbit Interlock Test chassis and cables

Picture 4.5b Test chassis and the summary chassis

The new test chassis included BL stoppers “in” test board and a 4-20mA transmitter box. The test chassis contains 18 differential pair transmitters that simulate hardware inside the BPLD chassis. With a channel switch in the up position, a summary of BPLD OK is simulated on the summary chassis. From there a “first event” of each BPLD channel is simulated. The BL stoppers “in” test board simulates a relay closure from a BL MPS PLC. With a dip switch in the “on” position it sends a 24 volt signal back into the summary chassis to meet certain logic conditions inside the FPGA. The 4-20mA transmitter box simulates the Stored Current Interlock Chassis current loop signal. The transmitter box is connected to a variable power supply and converted from a voltage to a current. The Current Loop Receiver board converts this current to a voltage that is amplified and monitored by the limit detectors described above.

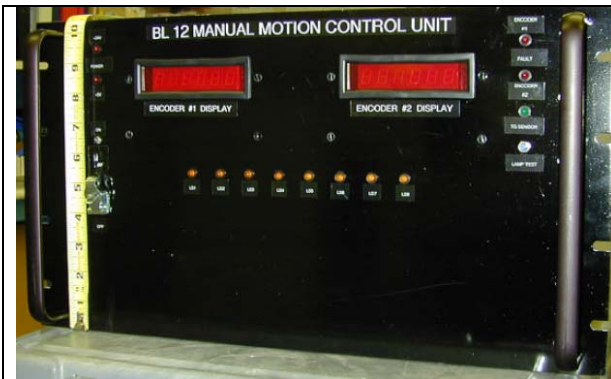
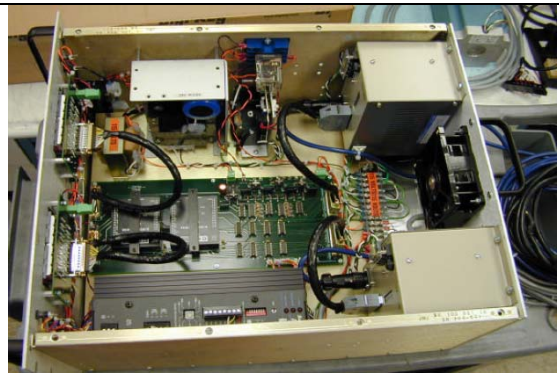
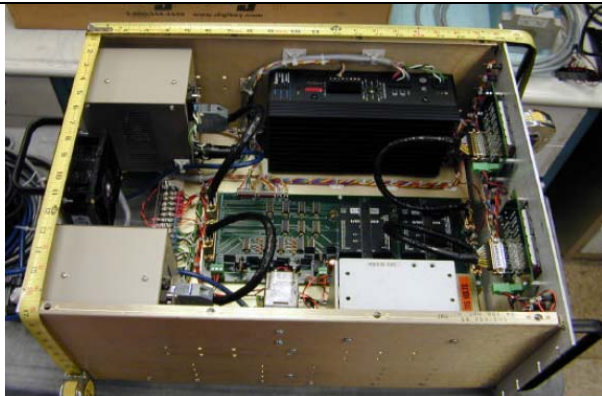
The Manual Motion Control Unit consists of a stepper motor driver, two encoder converters, +5VDC and +24 VDC power supplies, a logic board, two display boards indicating LEDs, and associated wiring, cables and accessories. For a more detailed description and operation of the BL 12 Manual Control Unit, please see the associated Operating Procedure. The unit was tested with an encoder, a spare stepper motor, and a limit switch board using a joystick.

Picture 5.1a BL12 Manual Motion Control Unit – Front View

Picture 5.1b BL12 Manual Motion Control Unit – Top View Left Side

Picture 5.1c BL12 Manual Motion Control Unit – Top View Right Side

Picture 5.1d BL12 Manual Motion Control Unit – Rear View

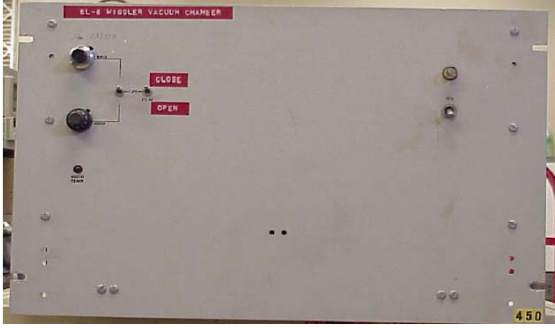
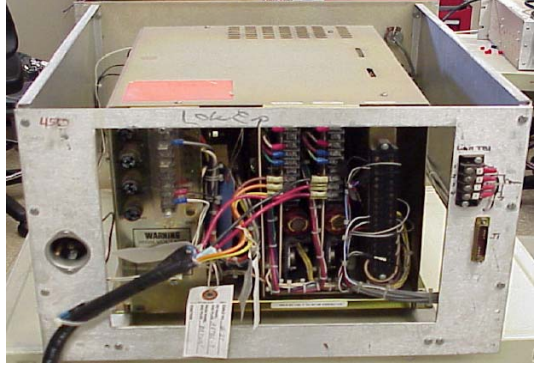
BL10, BL6, and BL5 motor driver chassis required modification because of exposed live terminals identified during a 2005 Beam Line safety inspection. When the chassis were removed and inspected a number of additional electrical code issues were identified. The chassis did not meet current OSHA, National Electric Code (NEC), and SLAC Electrical Safety requirements.

- a. Open rear panel with the exposed 120 VAC and exposed motor wires which contain high voltage and current.
- b. 120 VAC wires were too small and didn't meet NEC requirement.
- c. There was no ground wire.
- d. There were no top and rear panels on the chassis allowing tools or conductive objects to accidentally fall into the chassis, causing an electrical short or arc.

- e. The adjustable pots and switches didn't work, potentially confusing the operator
- f. The "Power" indicator light didn't work, (when the chassis was powered the light still indicated it was OFF).
- g. There were no handles installed on the front of the chassis so it was very difficult to safely remove or install it , (the chassis weighs over 50 pounds).

Picture 5.2a Typical Motor Driver before Modifications – Front View	Picture 5.2b Typical Motor Driver before Modifications – Rear View
After

Tom Dao and Scott Wallters repackaged the existing motor driver into two chassis bolted together to allow proper clearances. A power switch, fuse, and LED indication were incorporated to improve protection and facilitate safety during future maintenance activities. Each chassis was tested during the startup Insertion Device Check Out task. These newly repackaged chassis are fully enclosed, with proper labeling, fuse protection, and modular AC cords. In addition they have passed the Electrical Equipment Inspection Program inspection for electrical safety, in accordance with SLAC requirements for all custom and modified equipment..

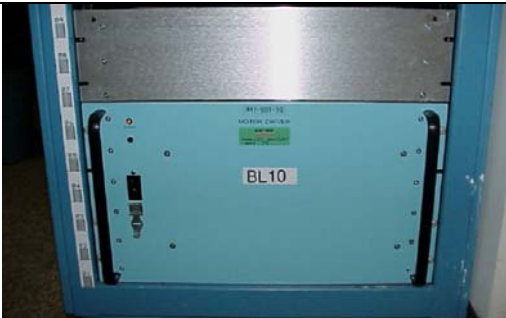
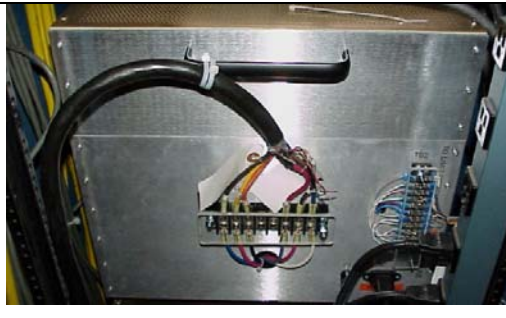
Picture 5.2c Typical Motor Driver for BL5, BL6 and BL10 after Modifications – Front View	Picture 5.2d Typical Motor Driver for BL5, BL6 and BL10 after Modifications – Rear View
