Introduction

Motion measurements were performed on the Stäubli RX160 robot per the specifications described in the SLAC statement of work (SOW) PS-391-000-86 on August 12th and 13th. The work was performed at the Stäubli Corporation North American Headquarters in Duncan, South Carolina. The following personal participated in the motion tests:

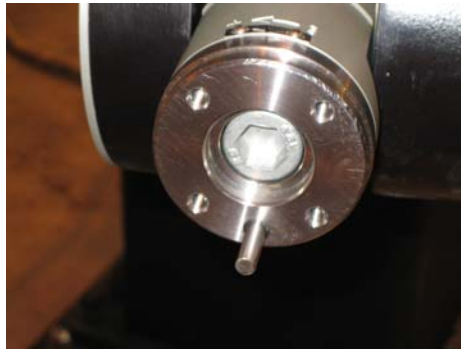
Figure 2: Image of the RX160 wrist and the mock detector mounting hardware.

An installed base RX160 robot* was outfitted with the mock detector displayed in Fig. 1. The mock detector was constructed of stainless steel and had approximate dimensions of 200 mm x 200 mm x 150 mm with a mass of 25 kg. Three ball mounted hollow retroreflectors were mounted to the mock detector to be used as reference datums for the laser tracker. The mock detector was fixed to the RX160 wrist with four screws and a pin (see Fig. 2).

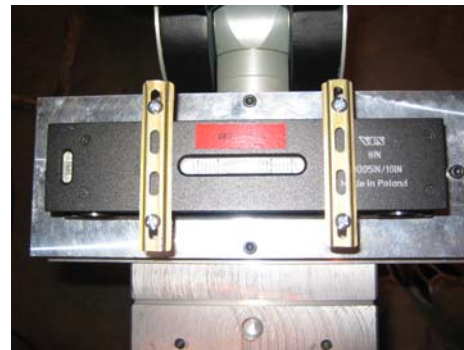
Figure 3: Image of the (a) keyence displacement sensor measuring along the X axis and (b) level used to measure the mock detector roll.

The position of the mock detector for the various tests described in this report was measured in two separate manners. For the first day of testing, a Keyence laser displacement sensor and level was used to measure the detector displacement along a single axis and detector roll respectively. This setup is displayed in Fig. 3. A Faro laser tracker, displayed in Fig. 4, was used on the second day to measure the 3-dimensional position of the L, M and R tooling balls mounted on the mock detector.

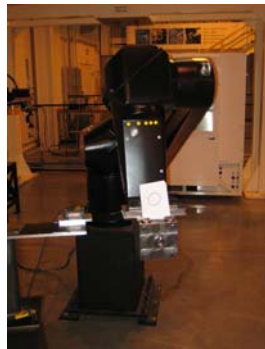
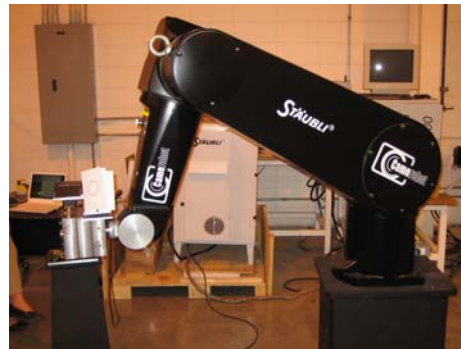
Figure 5: Detector position 0 front (a) and side (b) view.

Five points, labeled 0 through 4, were programmed into the robot control system to perform the position repeatability test. The placement of the programmed points was chosen to gravity load the robot joints in numerous directions and to exceed the 1.4 meter distance specified in the SOW. Images of the programmed points are displayed in Figs. 5-9. A Cartesian coordinate system was defined at the 0 position such that the Y axis was aligned with gravity (vertical), the X axis along the L to R Ball direction and the Z axis normal to the mock detector face.

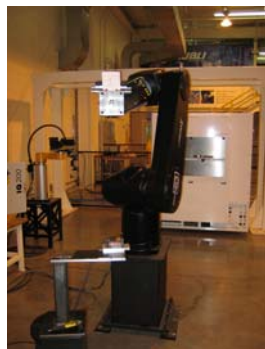
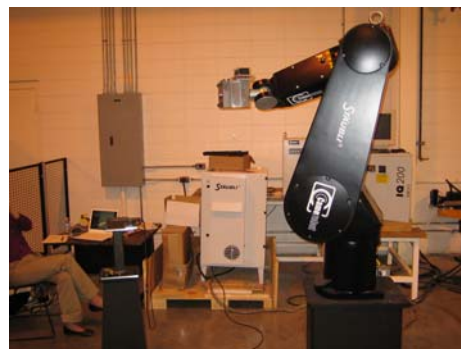
Figure 6: Detector position 1 front (a) and side (b) view.

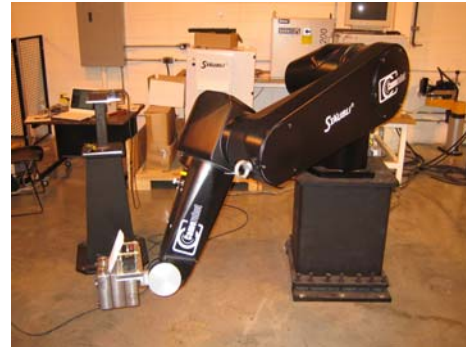
Figure 7: Detector position 2 front (a) and side (b) view.

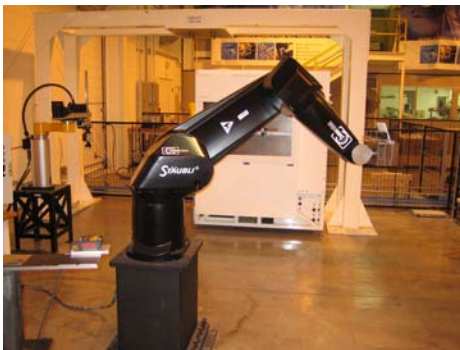
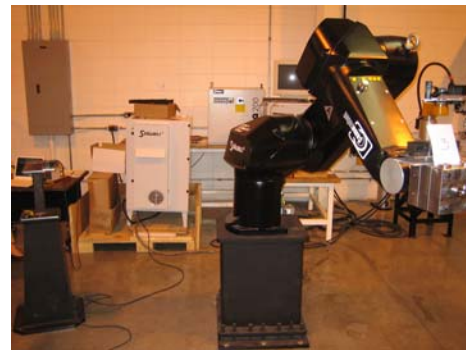
Figure 8: Detector position 3 front (a) and side (b) view.

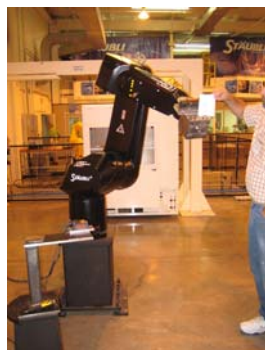
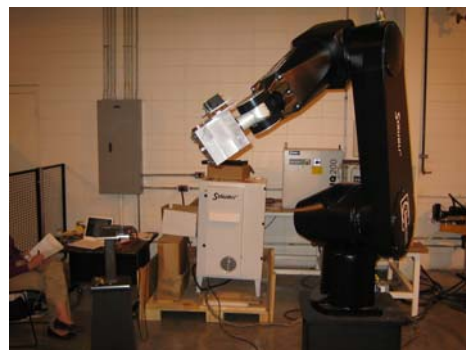
Figure 9: Detector position 4 front (a) and side (b) view.

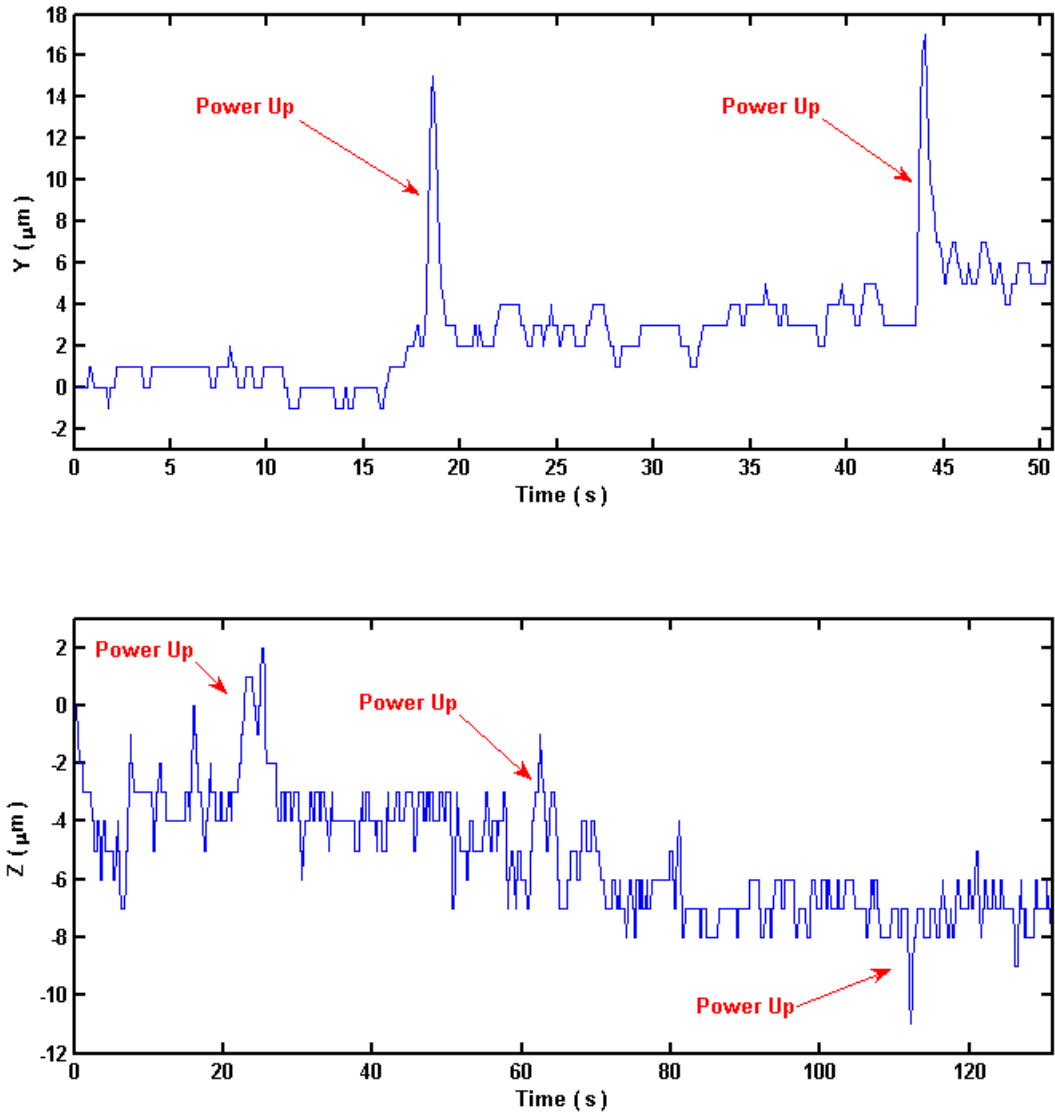
Figure 14: Y and Z position of the mock detector as a function of time. The power to the robot motors was turned off at the marked times. The measurements were acquired with the keyence gauge.

The Y and Z stability tests were repeated with higher sampling rates as the power to the robot motors was cycled. The purpose of these tests was to simulate the X-ray hutch entrance or egress of a experimenter. It is expected that an electrical signal that senses the hutch personnel protection state will be used to control power to the robot motors. The test results are plotted in Fig. 14. Position bumps, more prevalent in the Y direction, were evident upon motor power up. However, the position returned to the nominal value after a few seconds.
